# Task 62: Wear in Engines Using Alternative Fuels

## Wear associated with application of methanol in combustion engines Chinese experiences

September 2024

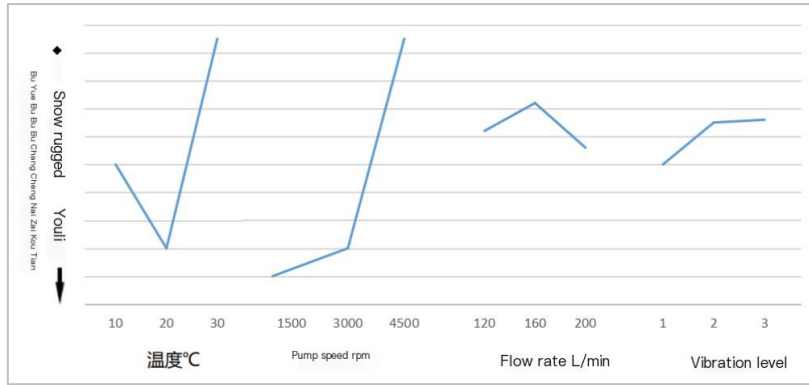
Figure 1.3 Factors affecting filtration efficiency

From Figure 1.3, it can be seen that 1. The temperature parameter will increase with the increase of temperature under certain low temperature conditions, but as the temperature continues to rise, the efficiency will actually decrease; 2. The maximum speed of the oil pump has the greatest impact on the efficiency of the filter; 3. The actual impact of flow on the filter is minimal; 4. Vibration has a significant adverse effect on efficiency, and the impact does not significantly increase when a specific vibration amplitude level is reached.

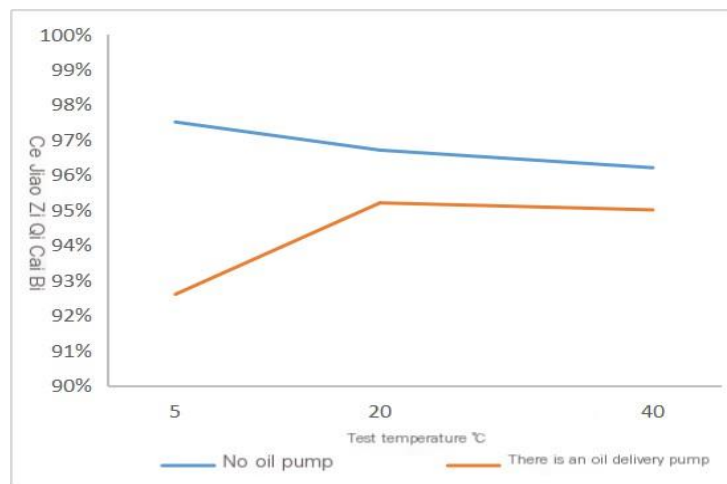
Figure 1.4: The mutual influence between fuel temperature and pump speed

As shown in Figure 1.4, there is a mutual dependence between the temperature of the fuel and the methanol fuel pump under actual operating conditions. The filtration

efficiency with and without oil pumps shows a significant trend of change. The results of the experimental report indicate that in the case of high viscosity fluids, when the filter is exposed to vibration conditions, the filtration efficiency is significantly reduced compared to low viscosity fluids. At the same time, it was also observed that the fuel pump has a significant impact on the filtration efficiency of the filter.

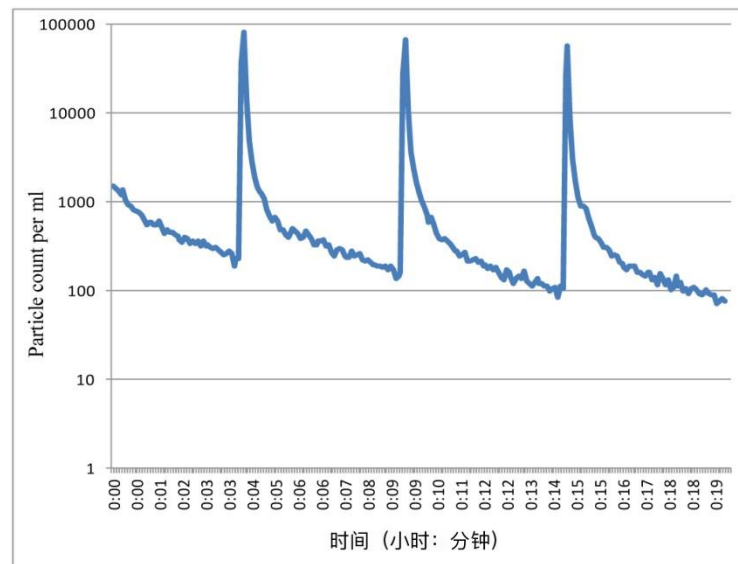
Compared to the standard filter testing method of ISO 19438, in the actual working conditions of vehicles, the fuel in the tank is relatively closed and there is no continuous addition of external pollutants. The fuel in the tank will return to the tank again with the circulation of the oil pump, and the content of pollutants will gradually decrease as shown in Figure 1.5.

*Figure 1.5 Changes in pollutant content in the fuel tank of a real vehicle over time*

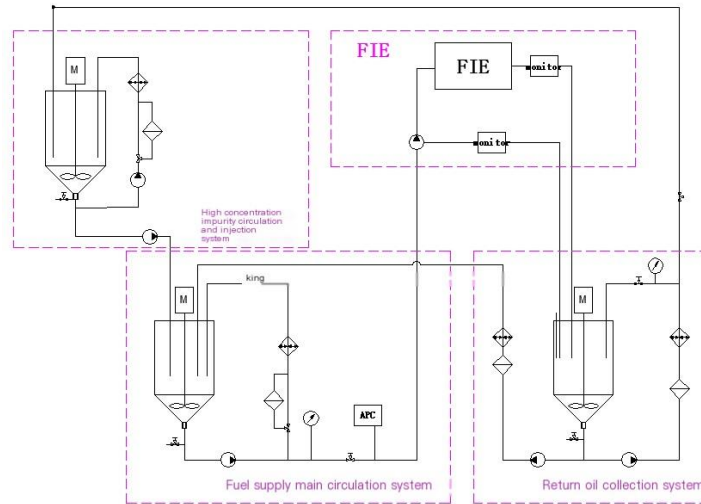
In order to conduct research on the strengthening and wear resistance of fuel systems, it is necessary to establish an independent fuel supply system to ensure stable pollution levels are obtained during the testing process. The testing process is shown in Figure 1.6.

Figure 1.6 Schematic diagram of a stable fuel pollution supply system

The use of a constant pollution concentration testing device can effectively ensure that the fuel supply system can continuously provide a stable concentration of test fuel. To ensure consistency of test results.

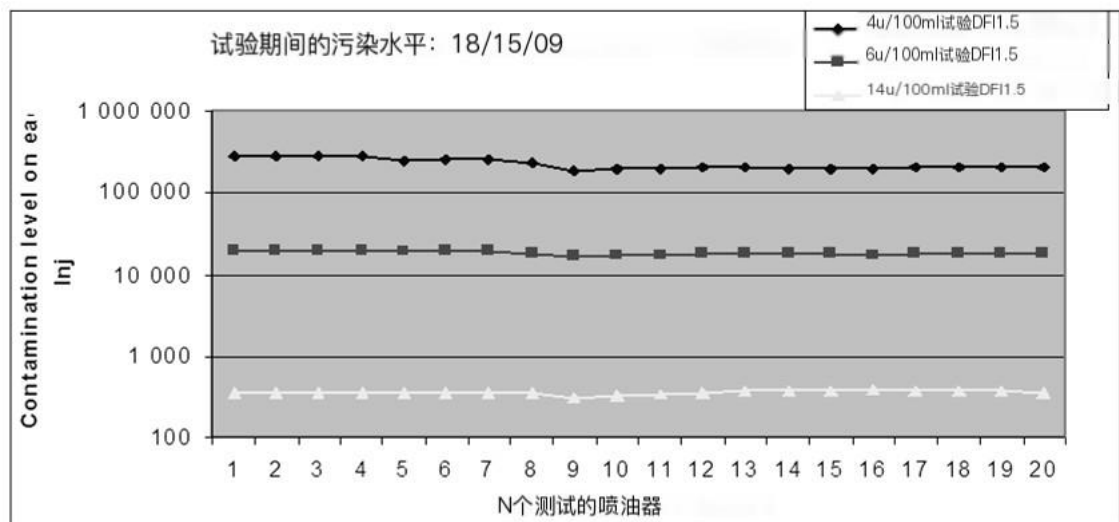
Figure 1.7: Fuel pollutant concentration at the outlet of a stable fuel pollution supply system

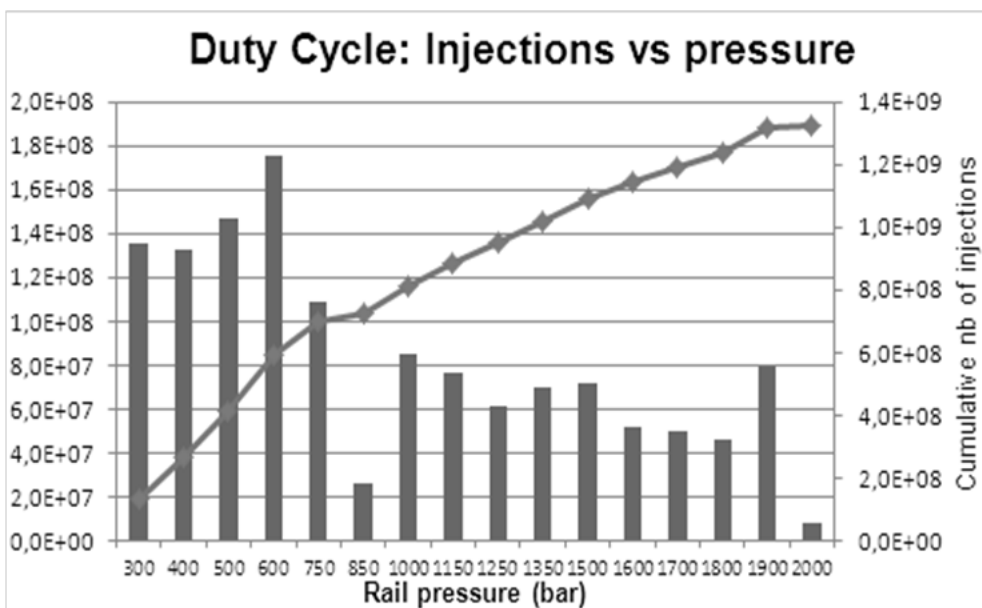
Figure 1.8 Duty Cycle

Figure 1.9 Spray VS Pressure

Figure 1.8/9 shows the test parameters of a certain 2.0 engine with a reference average speed of 40 km/h and an average fuel consumption of 6 L/min.

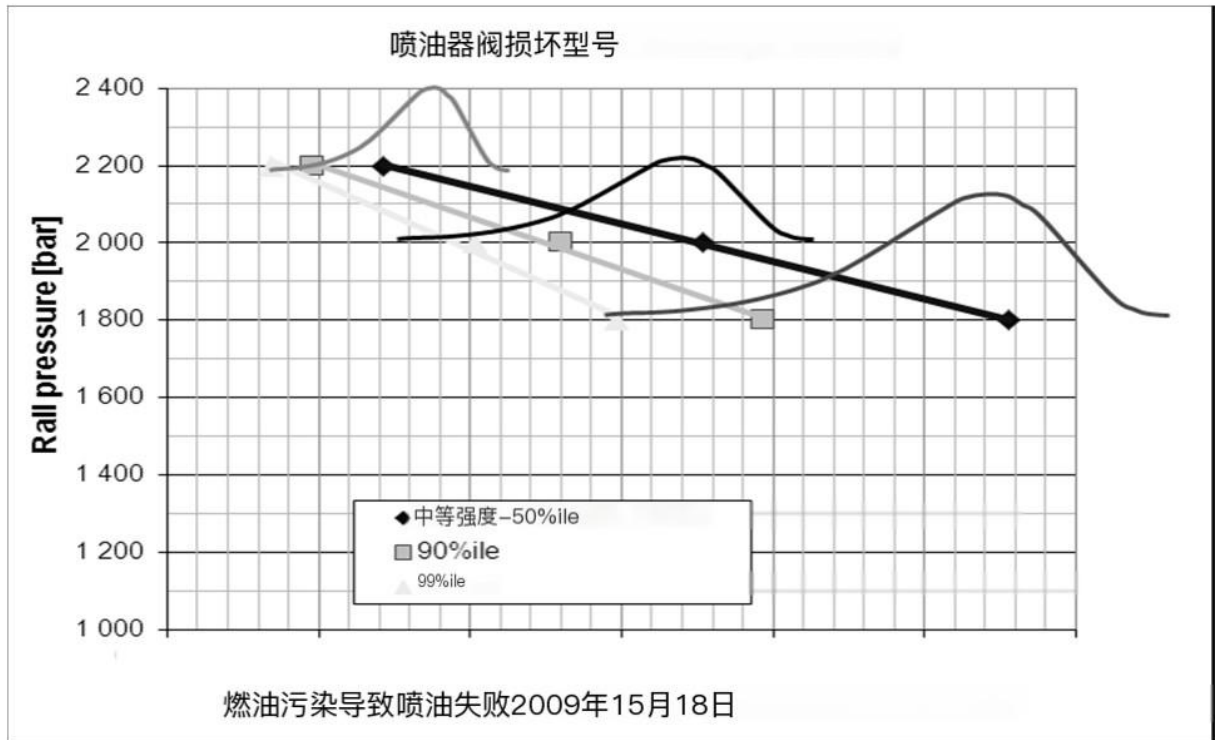
Figure 1.10 Fuel supply system intensity curve

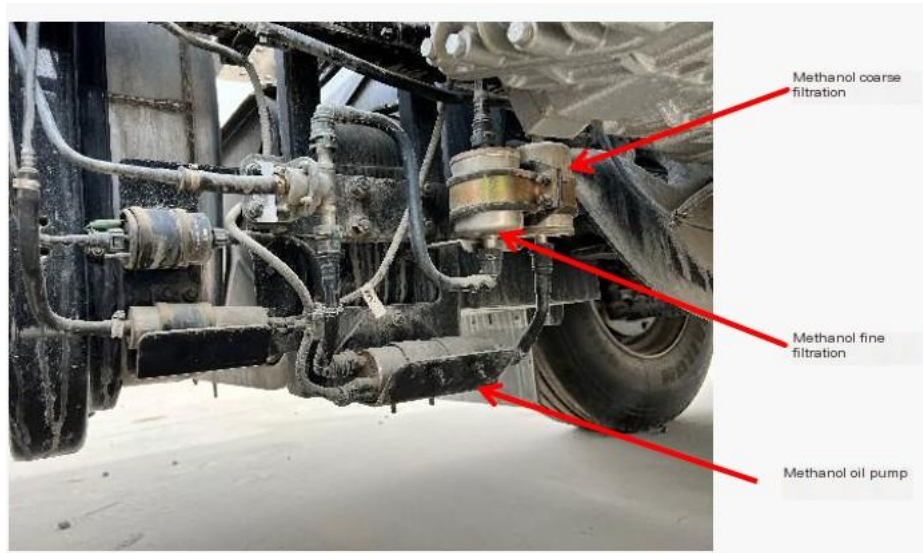
*Figure 1.14. Application of two-stage filtering on a certain vehicle model*

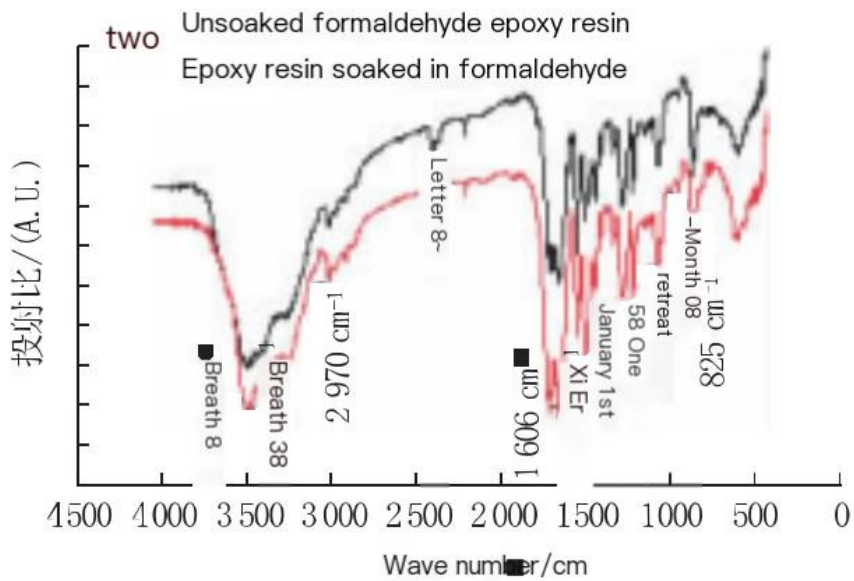
Two component epoxy resin adhesive is often used in traditional automotive filters to play a bonding and sealing role. However, studies have shown that after the resin is soaked in methanol, methanol can penetrate into the epoxy resin, causing partial hydrolysis of the epoxy resin and producing amine substances. Part of the amine substances exist in the resin, some dissolve out of the resin and enter the methanol solution, contaminating methanol [13].

Figure 1.15 FTIR spectroscopic analysis of epoxy resin before and after methanol immersion

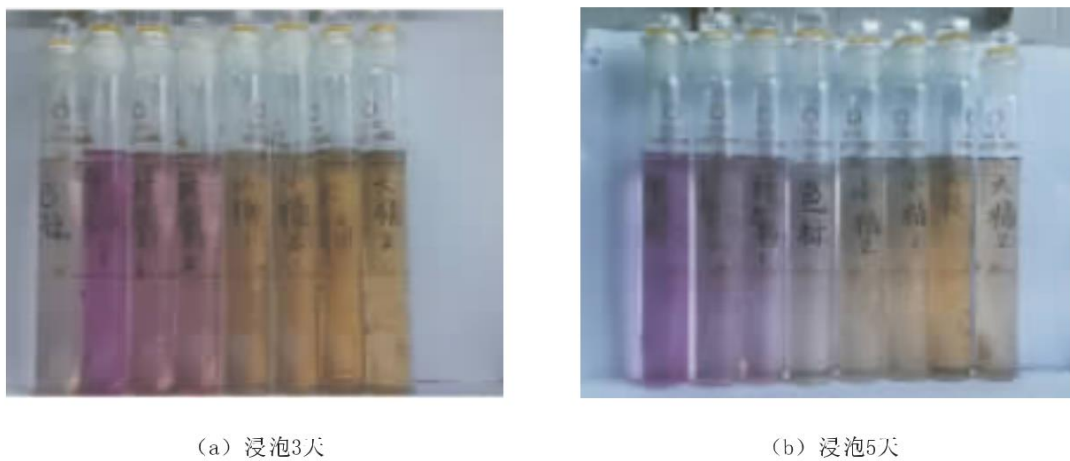
Figure 1.16 Color comparison of methanol samples with potassium permanganate added after different soaking times

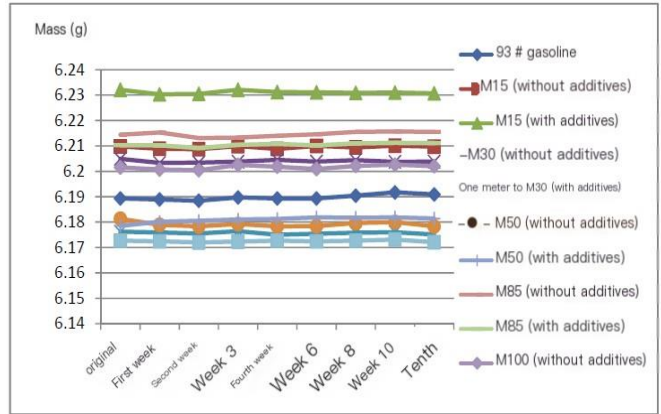
Methanol is corrosive to metal materials such as tin, lead, aluminum, copper, and magnesium, which can cause corrosion of metal components such as lead tin alloys, aluminum zinc magnesium alloys, and brass in the fuel supply system, leading to premature failure. The experimental results are shown in Figure 1.21.

*Figure 1.19 Analysis of the Effect of Different Methanol Concentrations on Different Metal Materials*

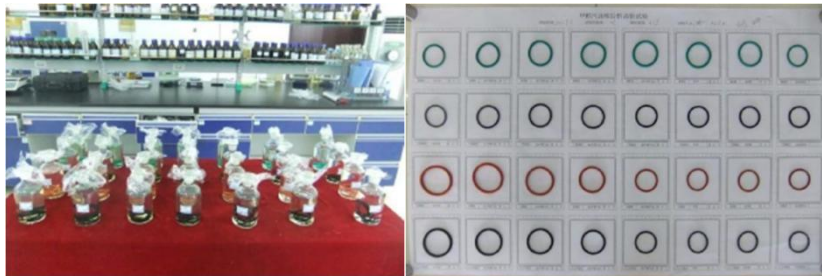
Methanol has a swelling effect on conventional rubber components, and in severe cases, it can cause them to melt, leading to premature sealing failure. Therefore, as shown in Figure 1.22, the macroscopic changes of different rubber materials were verified by soaking them in different ratios of methanol solution for different times, in order to find suitable methanol resistant rubber materials.

*Figure 1.20 Immersion of different rubber materials in solutions with different methanol concentrations*

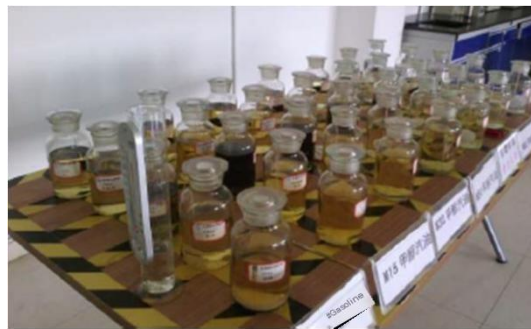
The swelling effect of methanol fuel on plastic materials can affect their performance, such as sealing, lubrication, mechanical properties, etc. As shown in Figure 1.24, the macroscopic changes of plastic materials were observed by immersing different plastics in methanol solutions of different proportions for different times. Search for suitable methanol resistant plastic materials.

*Figure 1.22 Analysis of the Effect of Different Methanol Concentrations on Different Plastic Materials*

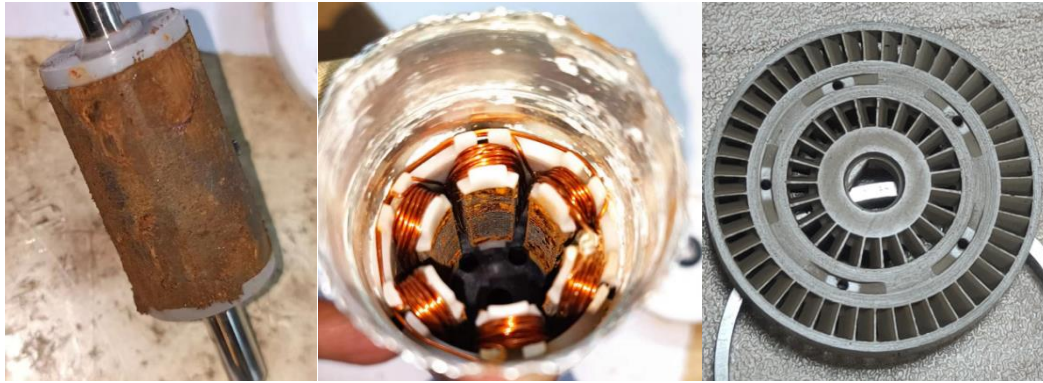
**(a) (b) (c)**

After long-term testing, the main failure modes of methanol pumps directly related to the use of methanol fuel are two aspects. On the one hand, the methanol pump rotor is stuck, resulting in the failure of the methanol pump function. On the other hand, the wear and tear of the impeller leads to an increase in internal leakage of the methanol pump and a decrease in oil supply capacity. In Figure 1.26, a and b show the rusting of the methanol pump rotor and stator, resulting in rotor jamming and methanol pump failure. In Figure 6, c is due to wear on the impeller end face, which leads to a

decrease in the oil pump's supply capacity and causes the oil pump to fail.

*Figure 1.24 Corrosion and wear parts of methanol pump moving parts*

In response to the corrosion and wear of the key components mentioned above, it is necessary to carry out anti-corrosion and wear-resistant treatment on these components. The main plan is as follows:

The solution to the rusting and jamming fault of the rotor and stator is to isolate the contact between the surface of the rotor and stator and methanol fuel, and to isolate the corrosion of methanol fuel on the surface of the stator through the use of encapsulation technology. At the same time, the rotor is wrapped in a stainless steel sleeve to solve the problem of rust and jamming on the surface of the rotor. In addition, during the operation of the methanol pump, the current continues to flow through the stator coil, further improving the insulation of the stator through encapsulation to prevent micro current leakage problems.

For the problem of fuel supply capacity degradation caused by impeller wear in methanol pumps. Due to the non lubricity of methanol fuel itself, and the corrosiveness of methanol fuel exacerbates the wear of the impeller end face, it has a greater impact on methanol pumps with lower speeds. The solution is as follows: replace the impeller material and use materials with better corrosion resistance and self-lubricating performance, such as PEEK. In addition, increase the rated operating speed of the methanol oil pump to reduce the impact of impeller end face wear on the oil supply capacity of the oil pump assembly.

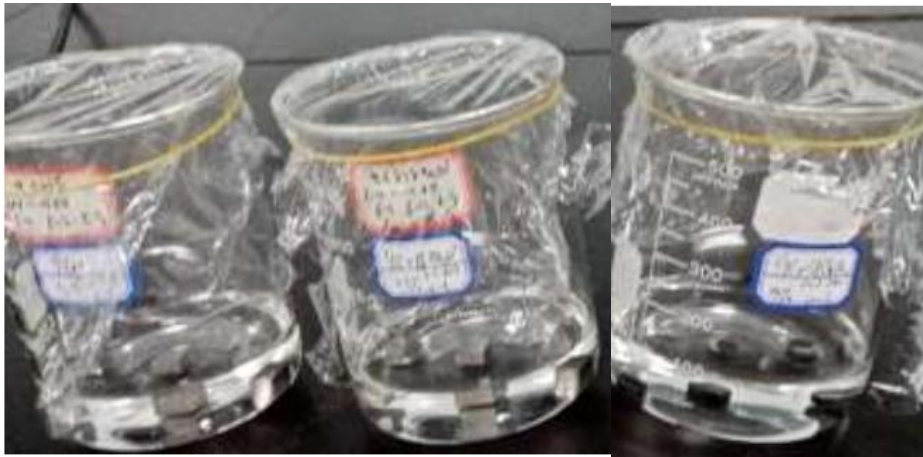
(1) Observe the color change of the test medium before and after soaking  
Due to the strong volatility of methanol, as shown in Figure 2.1, the test sample was immersed in the test container and sealed with a thin film bag. A pure methanol corrosion test was conducted at room temperature. After soaking for 25 days, the color change of the test medium before and after soaking was observed. As shown in Figure 2.2, after the test specimen is immersed in the test container, the solution in ordinary carbon steel undergoes chemical corrosion and turns brown, while in martensitic stainless steel, the solution turns light brown. The color of martensitic stainless steel+surface coating remains unchanged.

*Figure 2.1 Image before soaking in the test*

*From left to right are ordinary steel, martensitic stainless steel, martensitic stainless steel+surface coating*

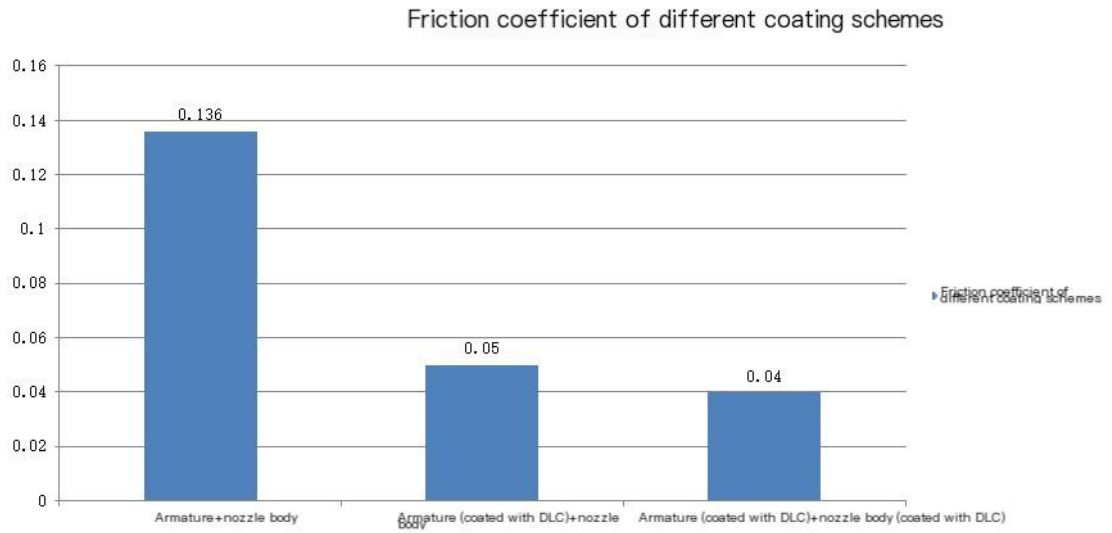
As shown in Figure 2.6, from the data, the friction coefficient of the two parts without coating is 0.136, and the friction coefficient of both parts with coating on the surface is 0.04. After adding coating on the surface, the friction coefficient significantly decreases; The friction coefficient of one of the two parts with a surface coating (armature surface coating) is 0.05. Compared with the non coating scheme of the two parts, the friction coefficient of this scheme is also significantly reduced. Compared with the coating scheme of both parts, the friction coefficient is close.

*Figure 2.6 Comparison of friction coefficients between different coating schemes*

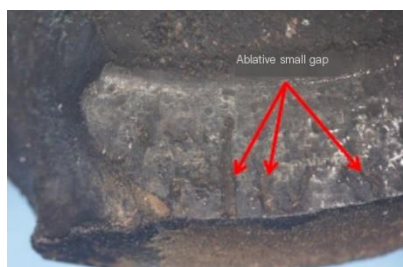
Figure 3.3 Morphology near the ablation area of the exhaust valve

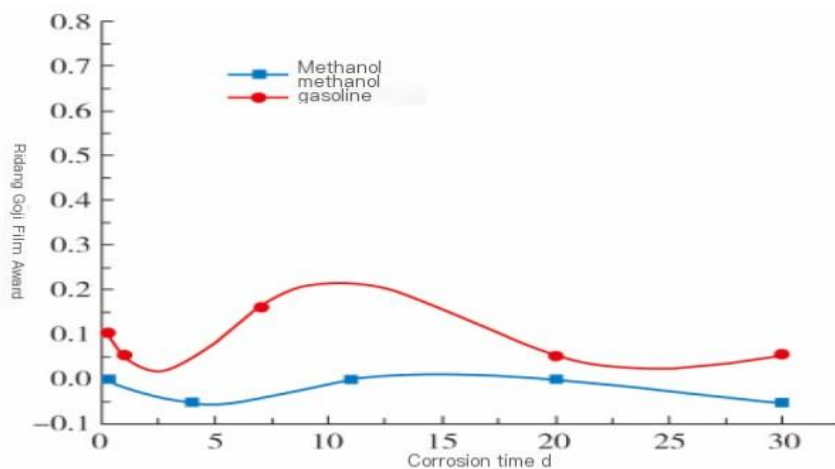
Figure 5.1 Corrosion rate of pure methanol and methanol gasoline on cast iron materials

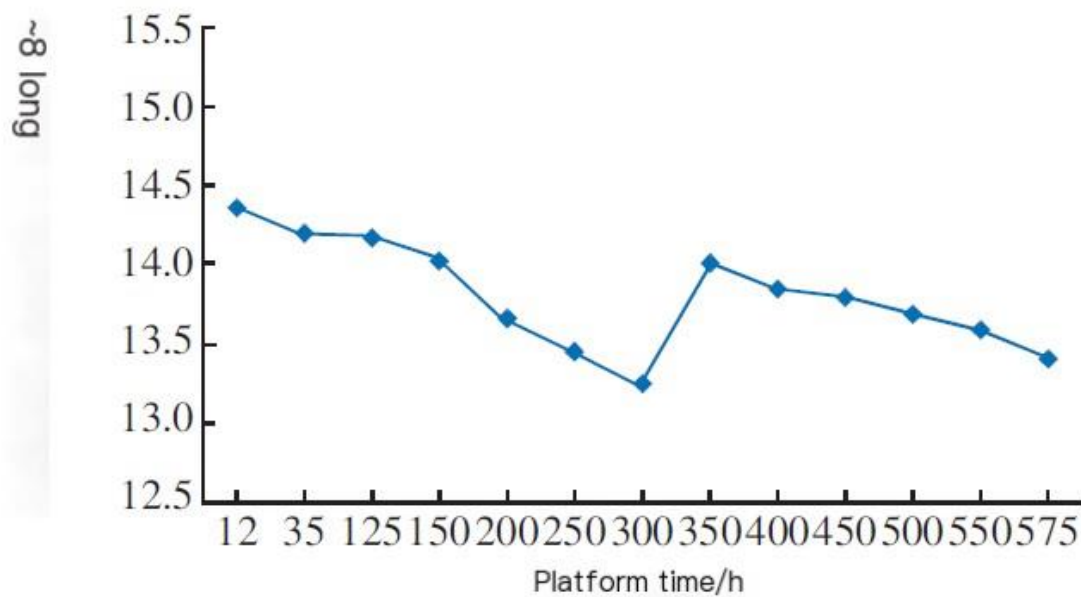
Figure 5.8 Changes in oil viscosity over test time

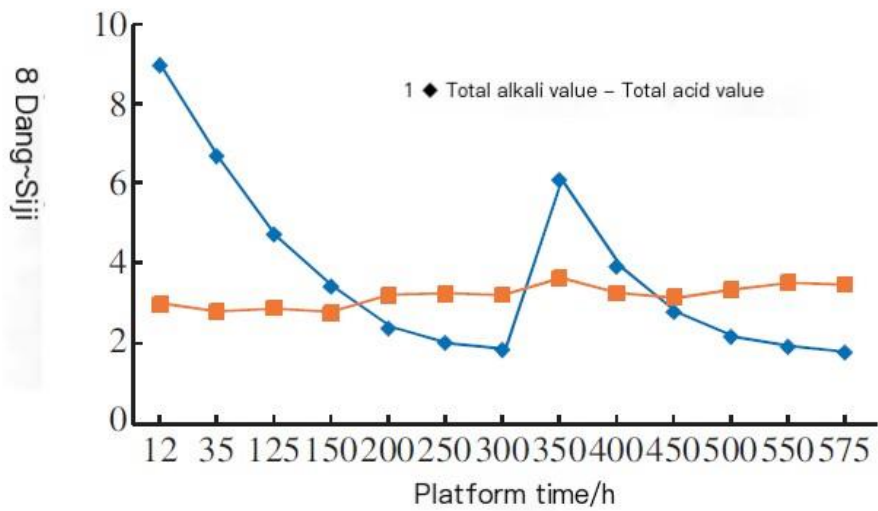
Figure 5.9 Changes in total alkaline value of oil products over test time

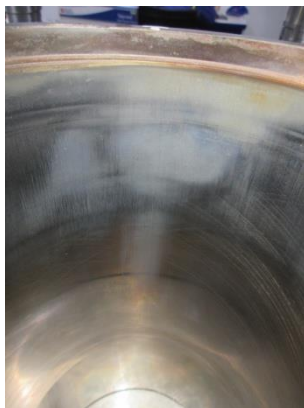
Figure 5.13 Morphology of cylinder liner inner ho

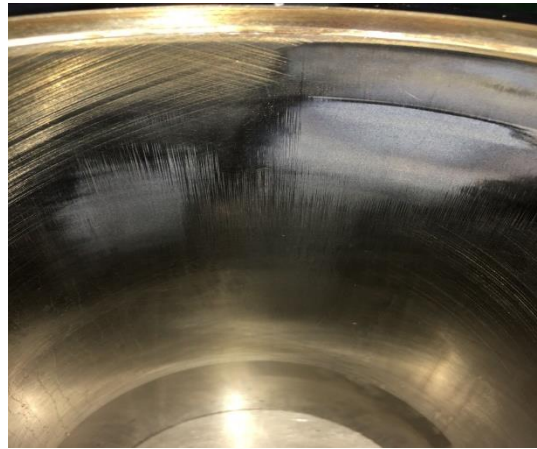
Figure 5.15 Bore morphology of corrosion-resistant gray cast iron cylinder liner after 1500 hours of operation

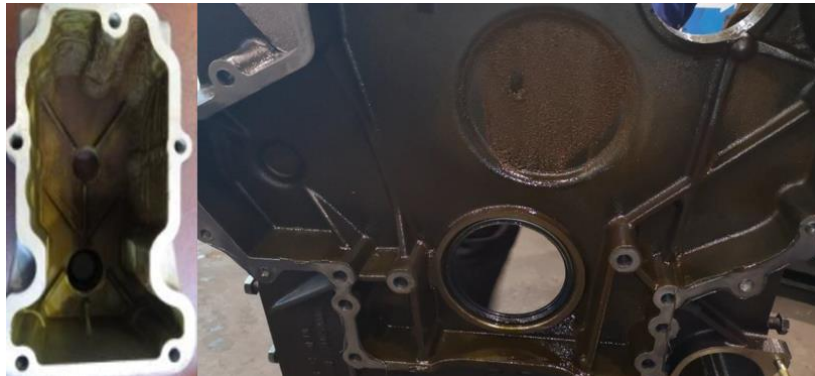
Figure 8.4: Oil sludge situation for reliability of heavy-duty methanol engines

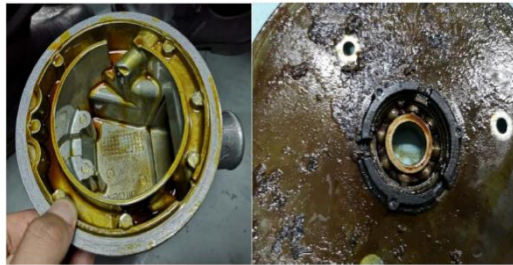
Figure 8.5 Corrosion of Oil Gas Separator for Reliability of Heavy Duty Methanol Engine
